**Architect's Field Report**

5465 Interstate 55 North Frontage Rd, Jackson, MS 39206

14 October 2022 ..... Date of Site Visit

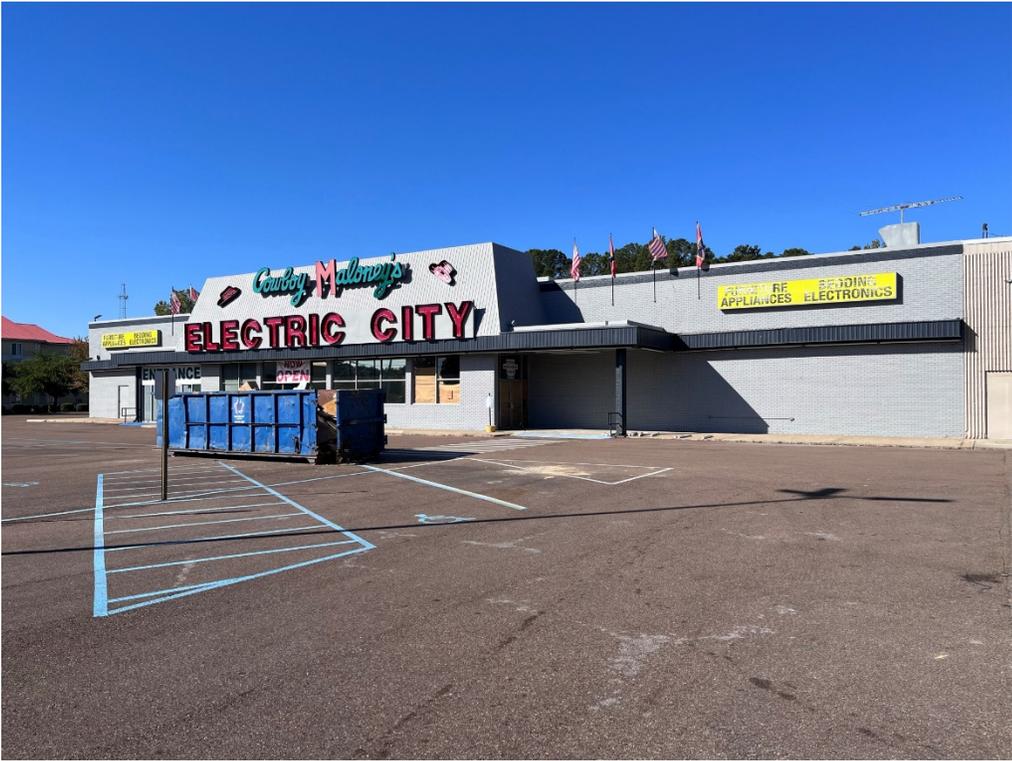
At the exterior, the contractor should ensure that the dumpster is closed properly each day and possibly locked if issues with others arise.

Figure 1 – Property Front; Dumpster needs to be closed fully each day

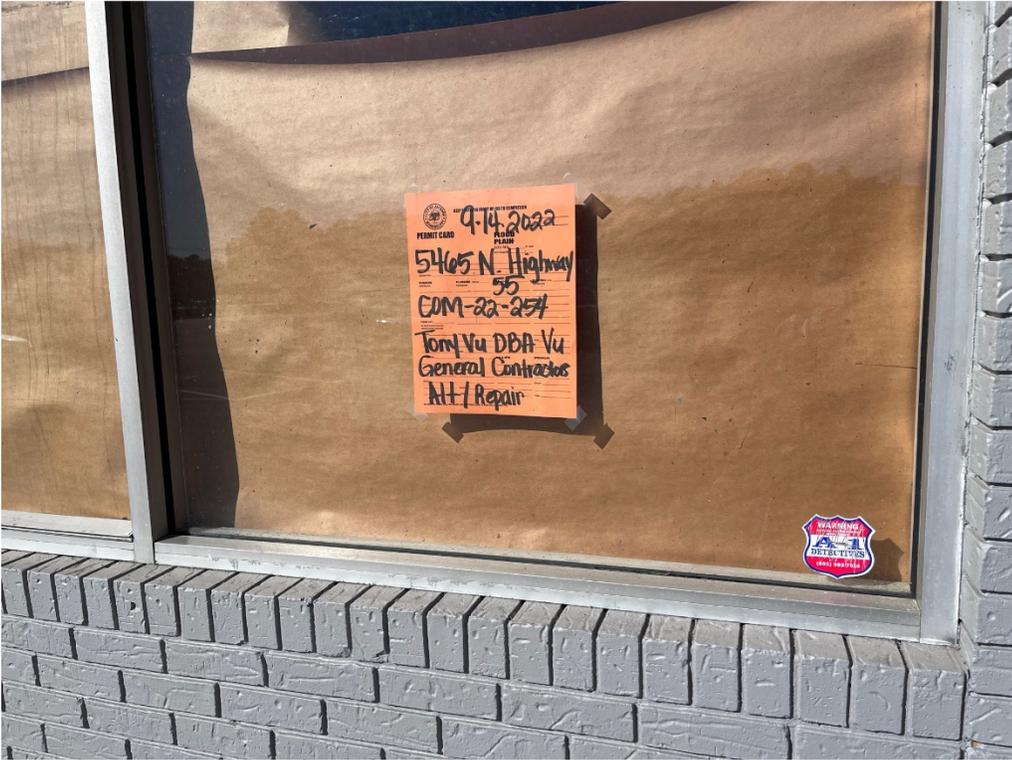
Figure 2 – Permit displayed at Building Front

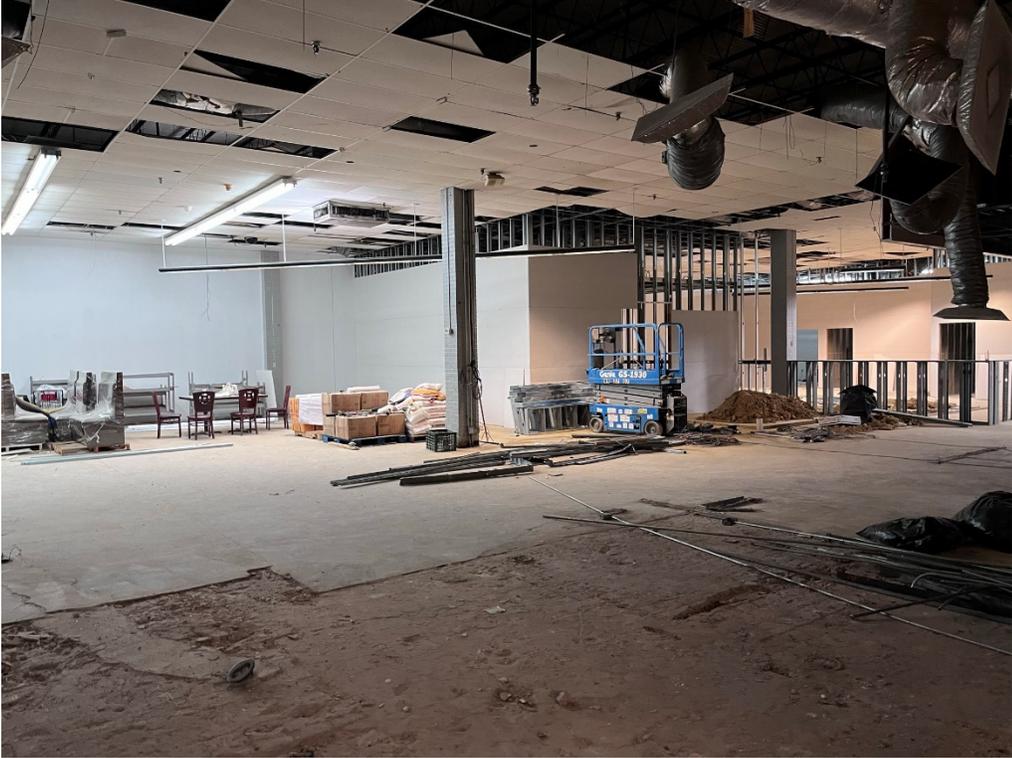
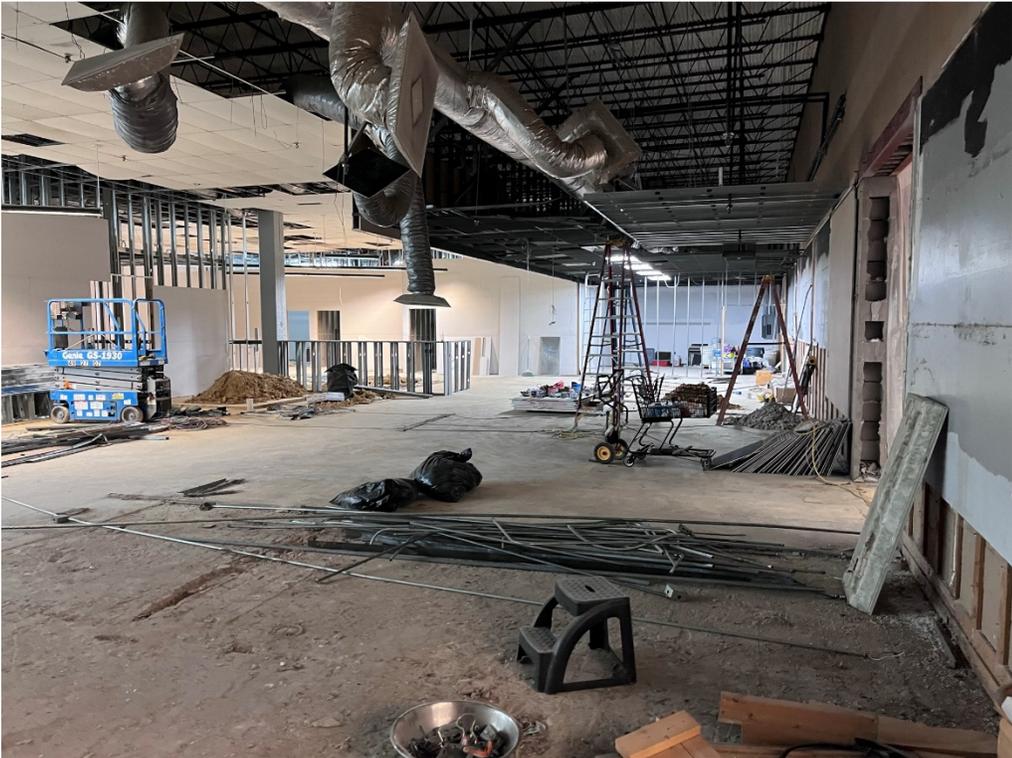
Figure 3 – Renovation Progress from NE Entry

Figure 4 – Renovation Progress from NE Entry

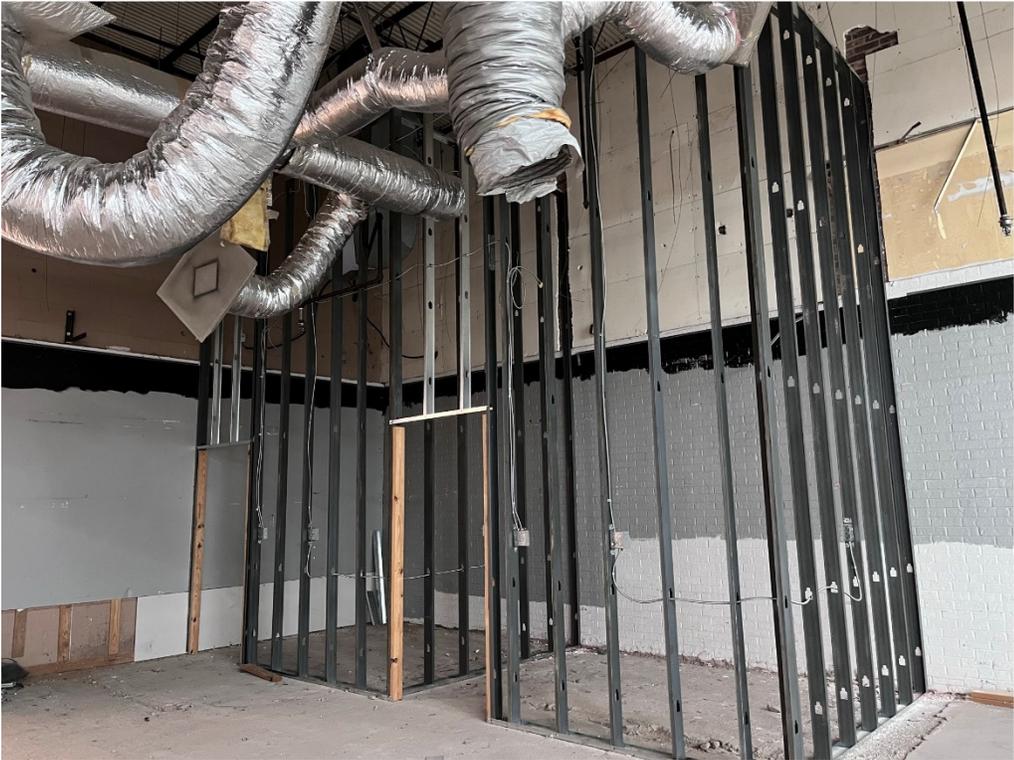
Figure 5 – NE Rooms Framed

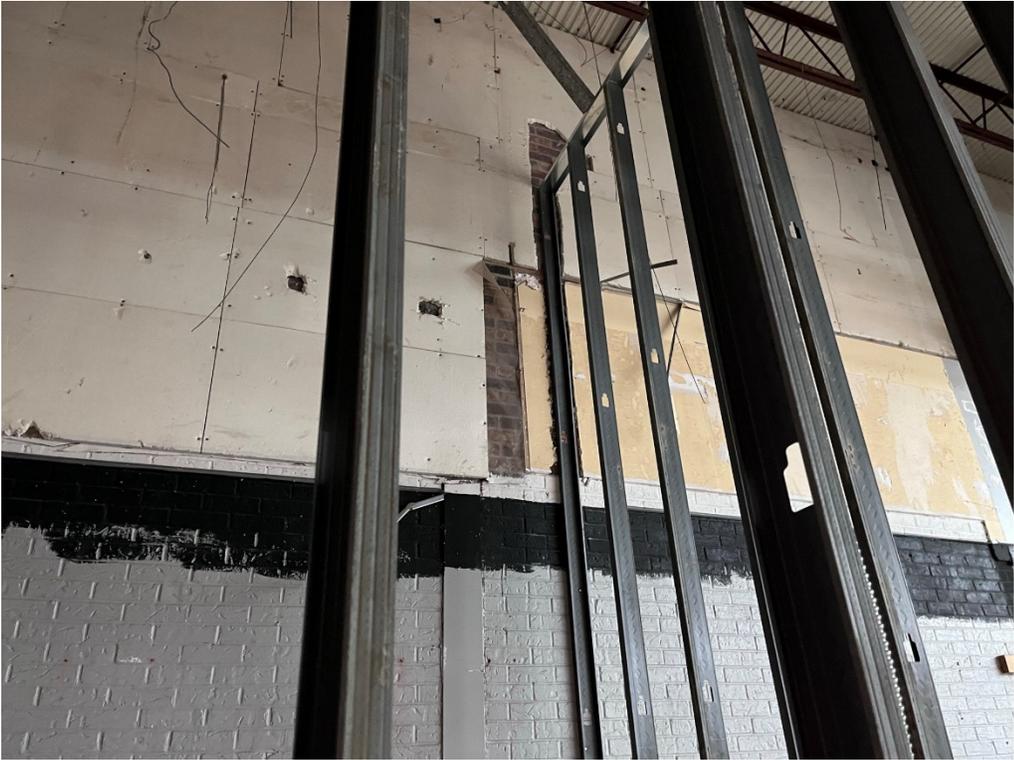
Figure 6 – East Wall Framing Secured to Brick Thru Drywall

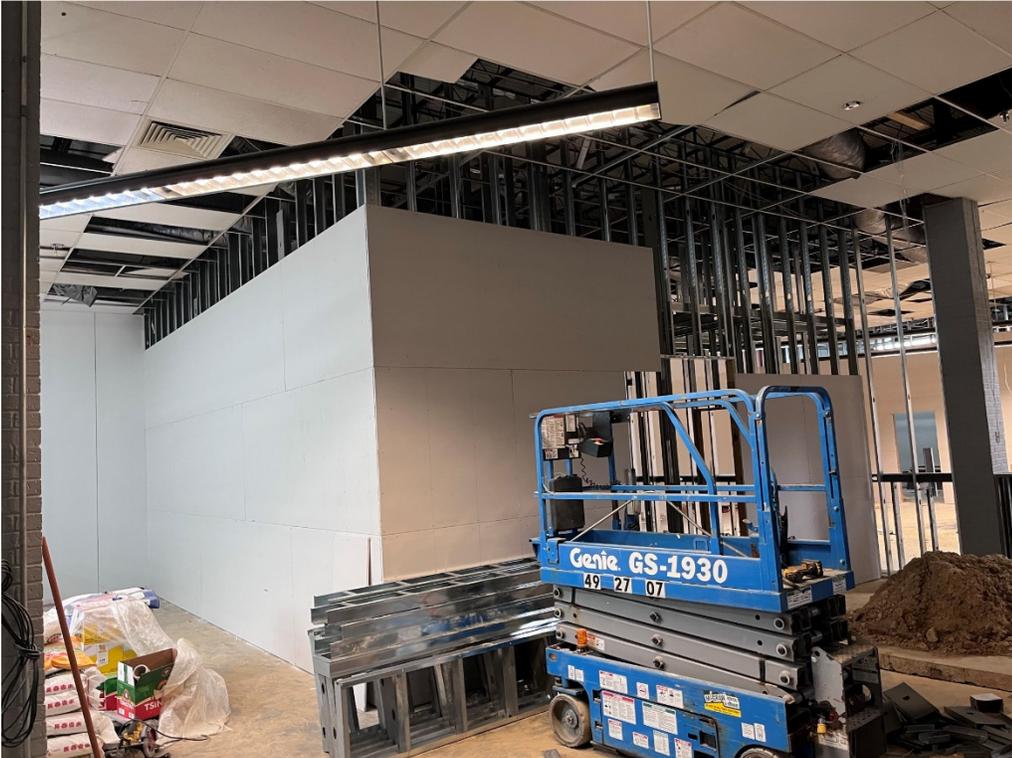
Figure 7 – Partially Drywalls Toilet Room

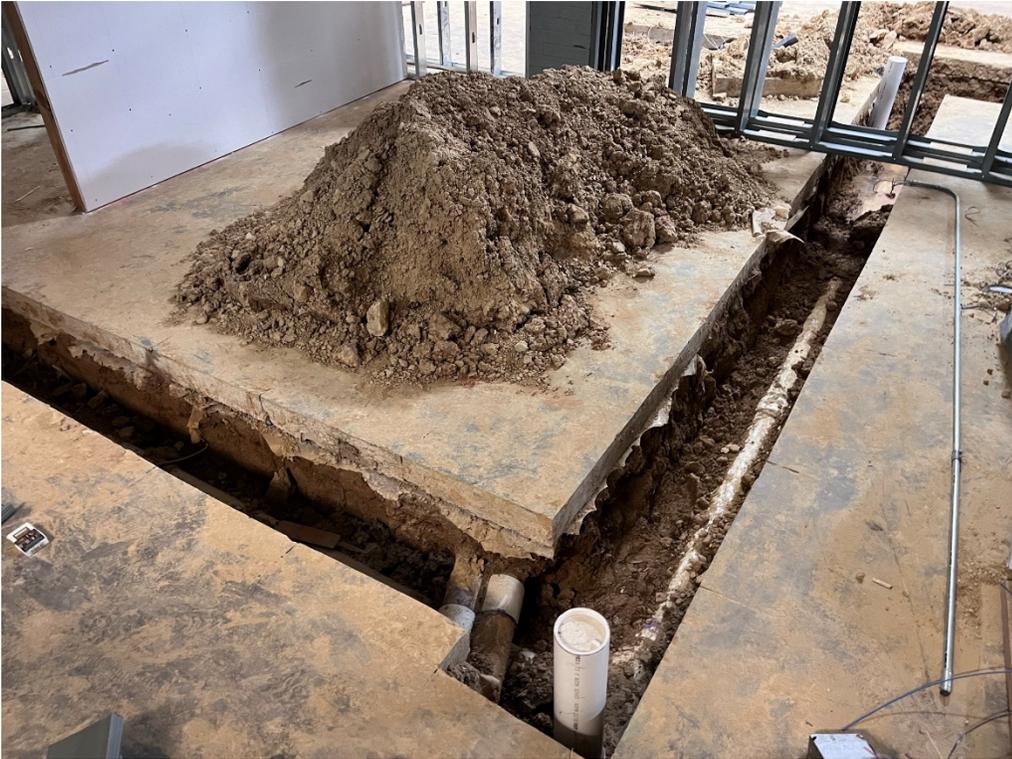
Figure 8 – Excavation Remains Open

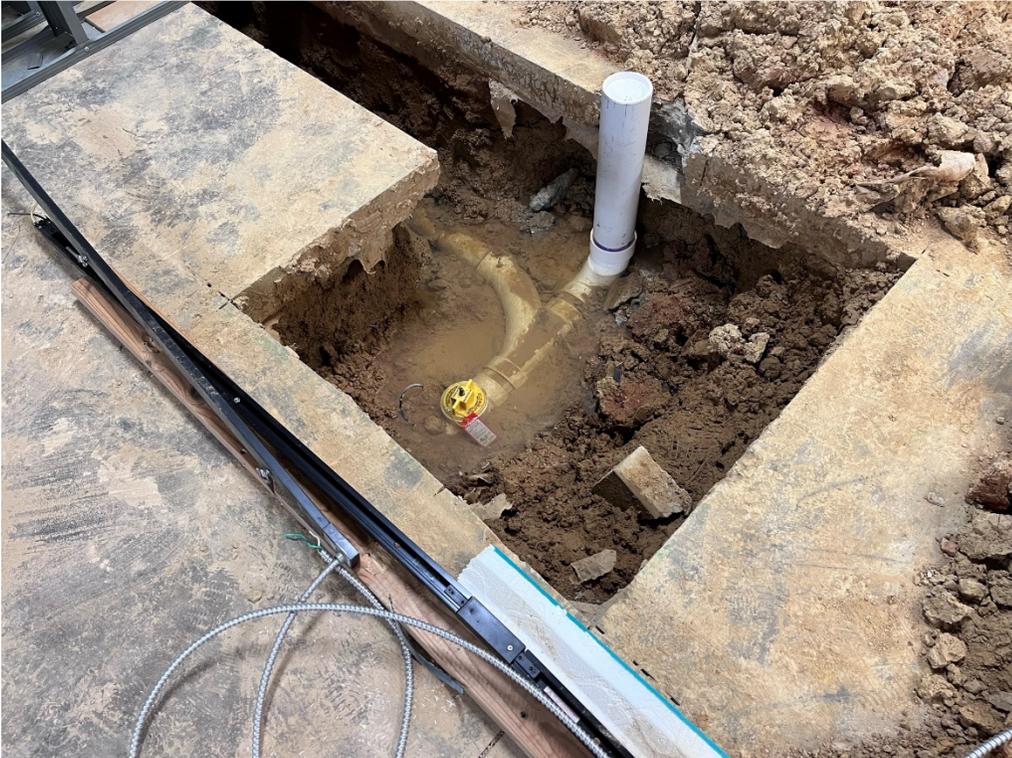
At the interior in one of the excavations, there is standing water which was noted in my last field report; is this due to leaking new plumbing? Will the contractor clear this water and prior to covering under slab, prove to the owner that this will not be an ongoing issue?

Figure 9 – Where is this water coming from?

- 1. Explain water situation at excavation

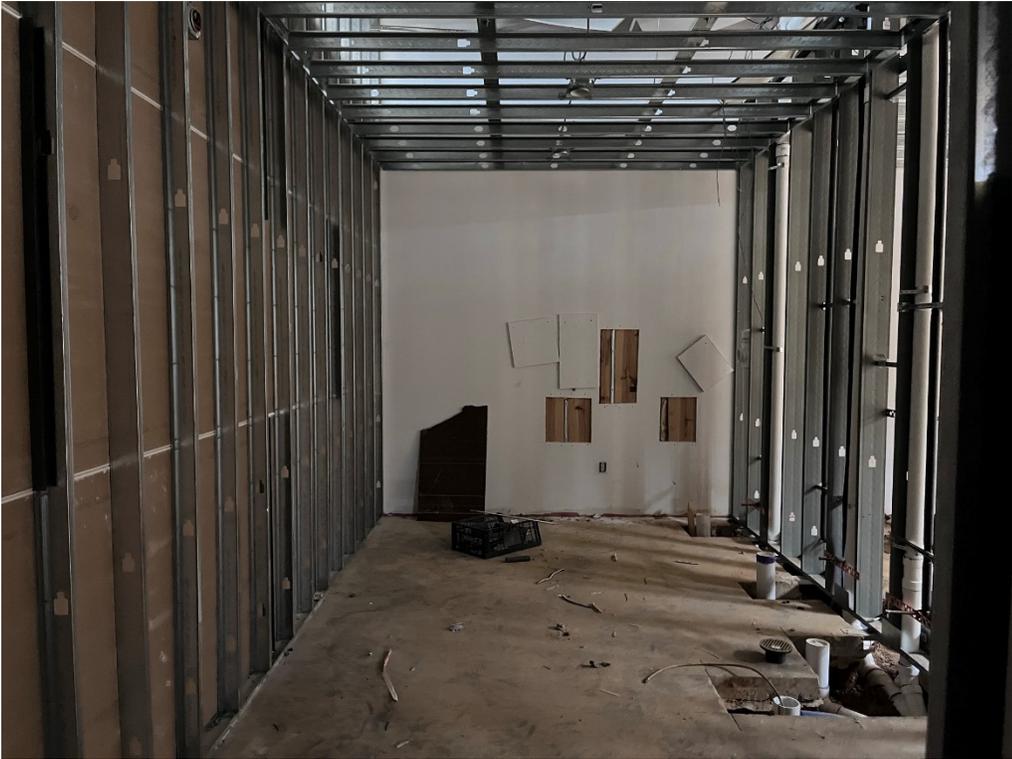
Figure 10 – Toilet Room Progress

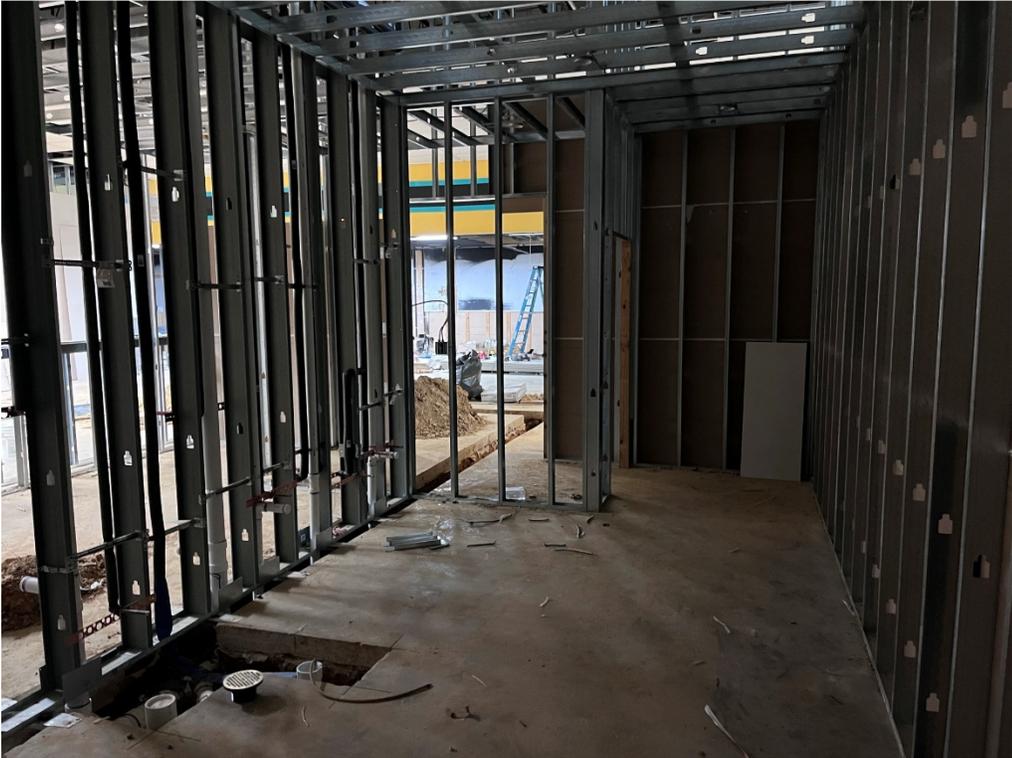
Figure 11 – Toilet Room Framing

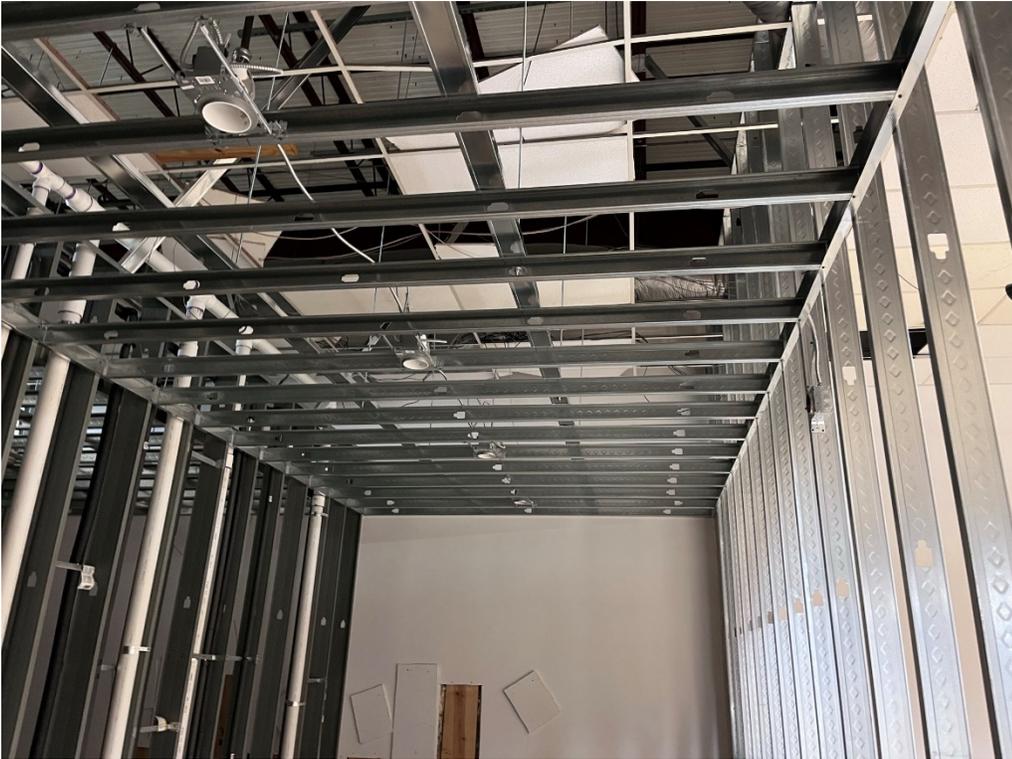
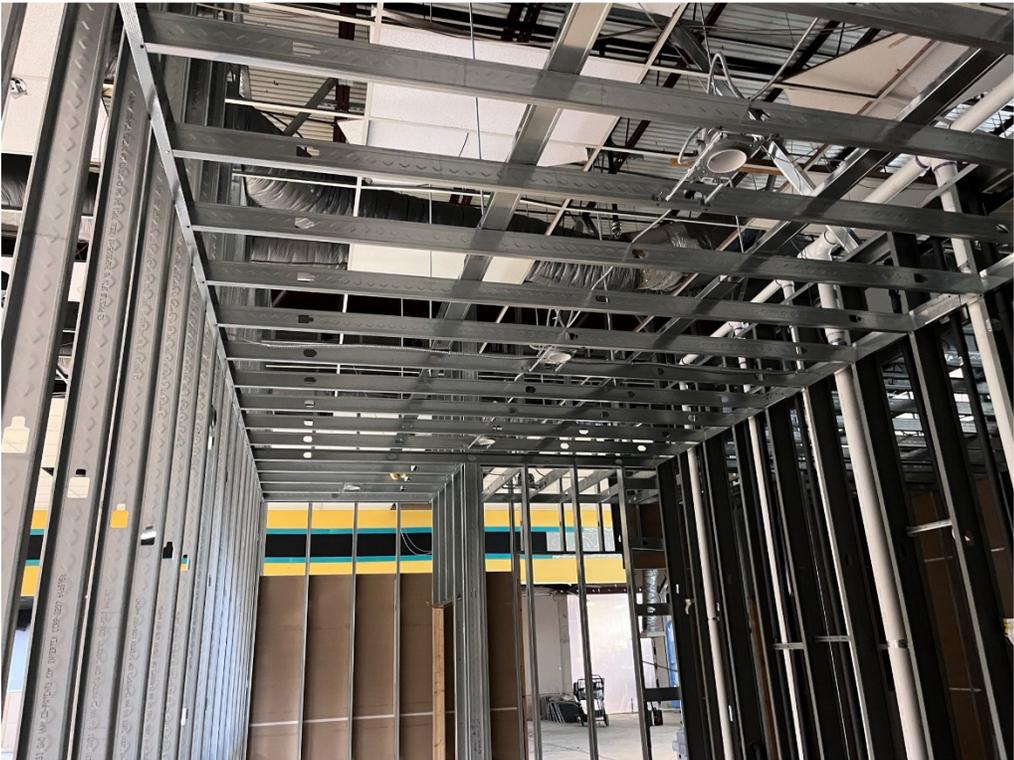
Figure 12 – Toilet Room Framed Ceiling

Figure 13 – Toilet Room Framed Ceiling

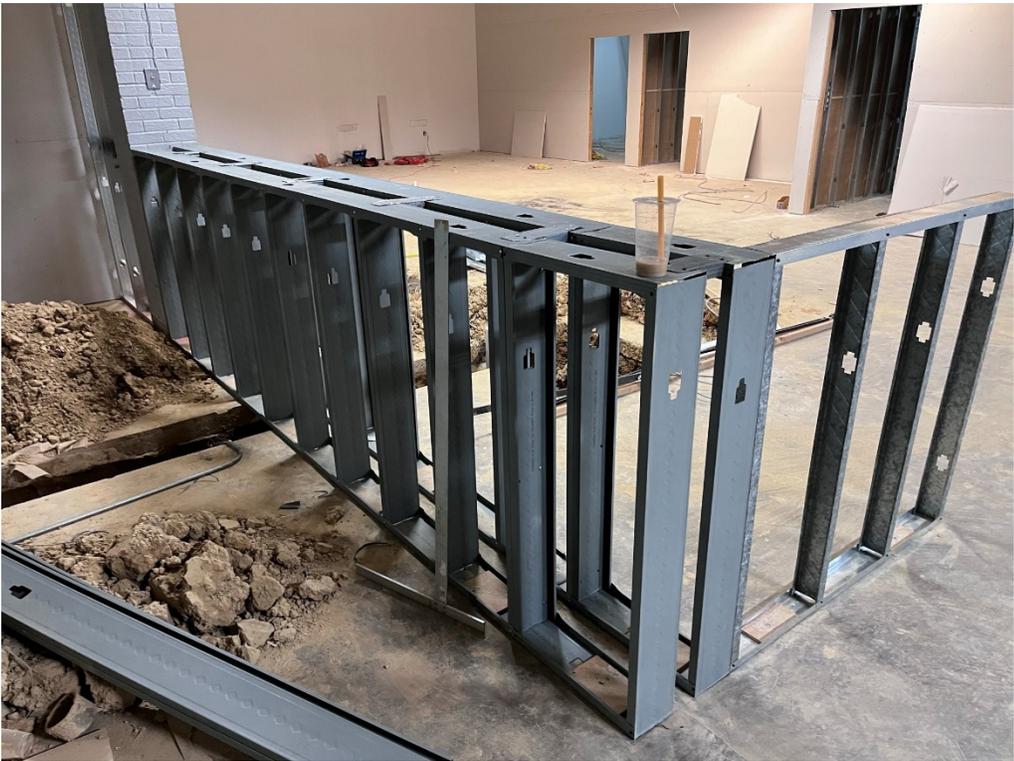
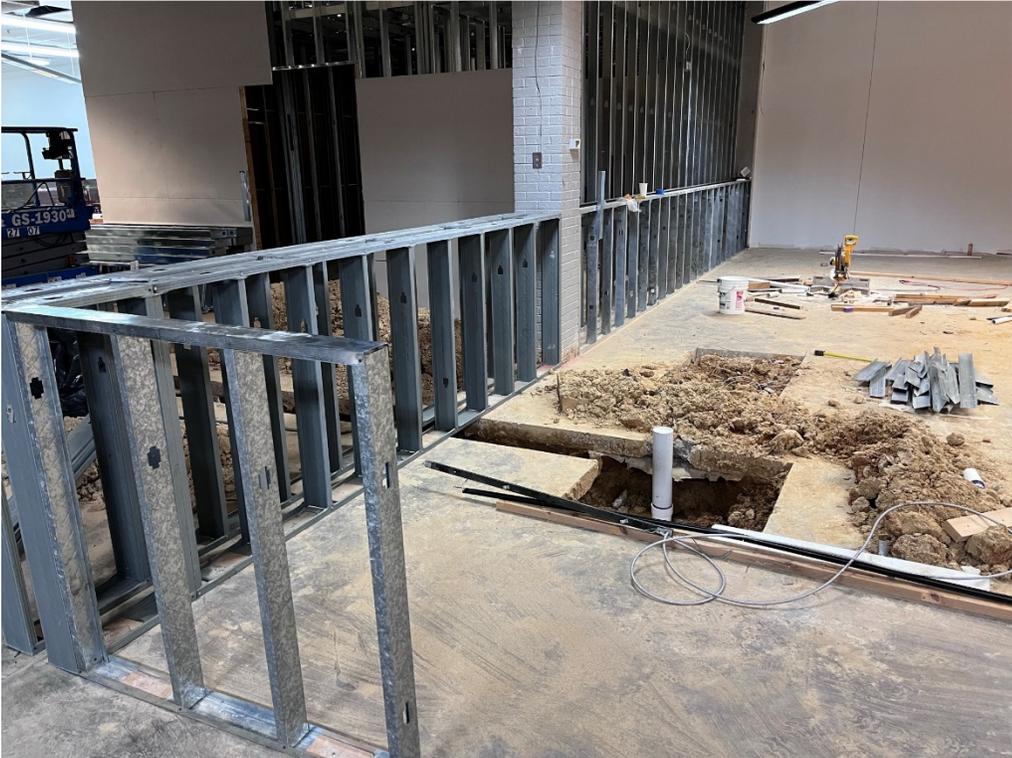
Figure 14 – Short Wall Framed at Dining

Figure 15 – Short Wall Framed at Dining

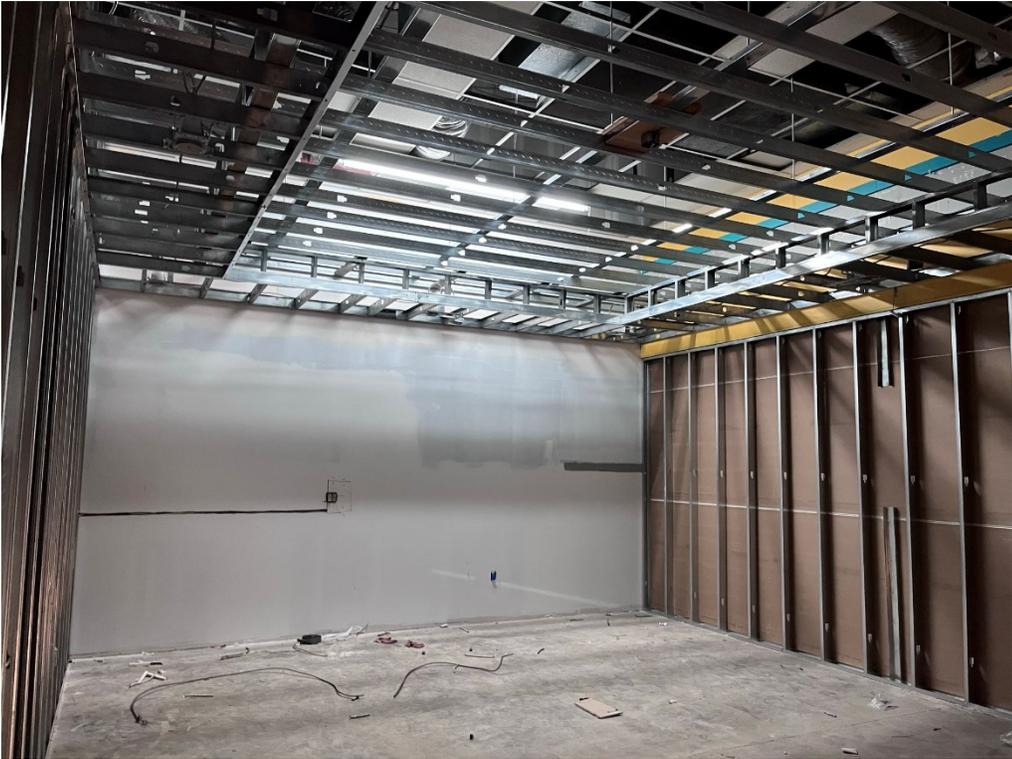
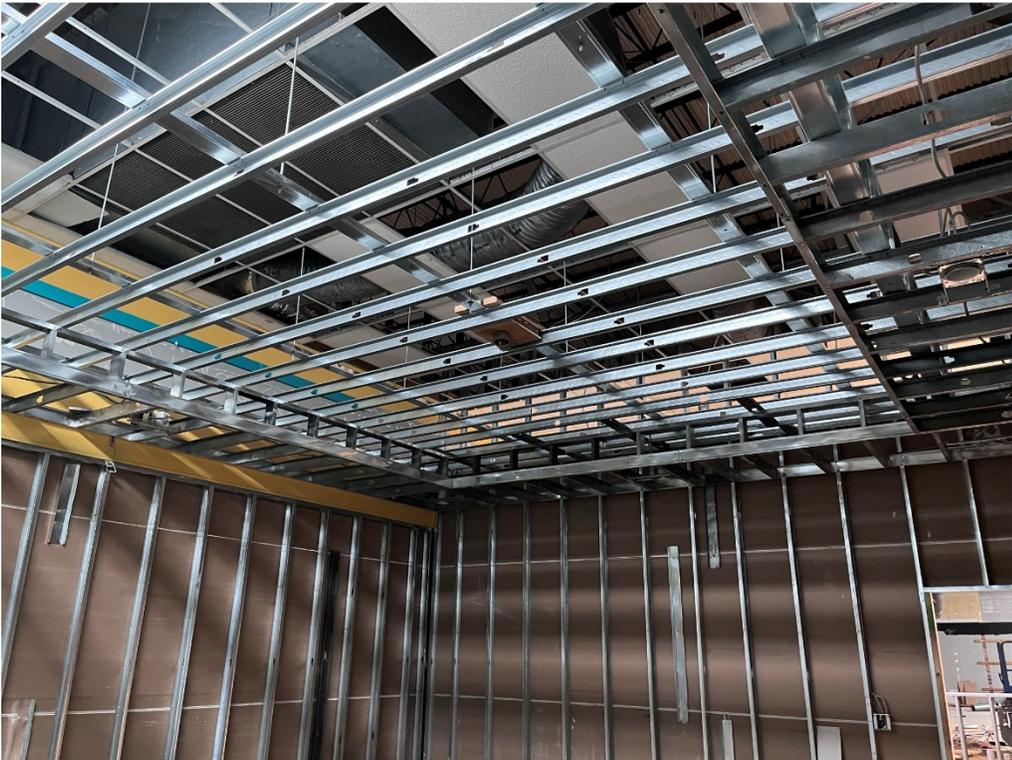
Figure 16 – W Room Coffered Ceiling Added

Figure 17 – W Room Coffered Ceiling Added

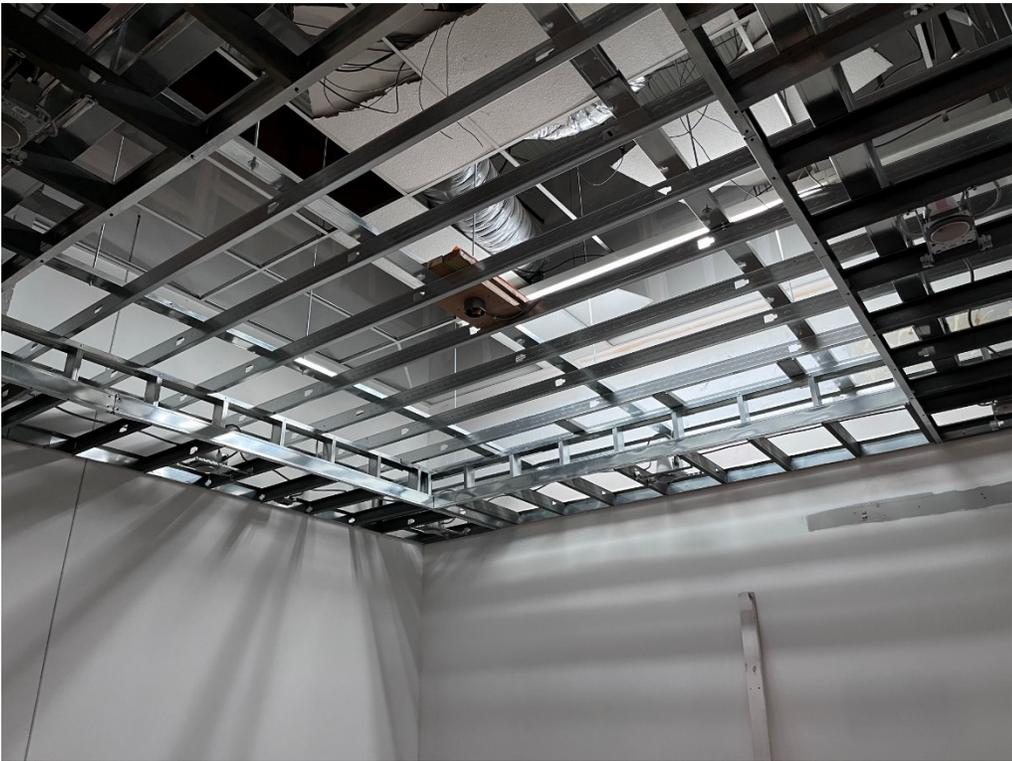
Figure 18 – SW Room Coffered Ceiling Added

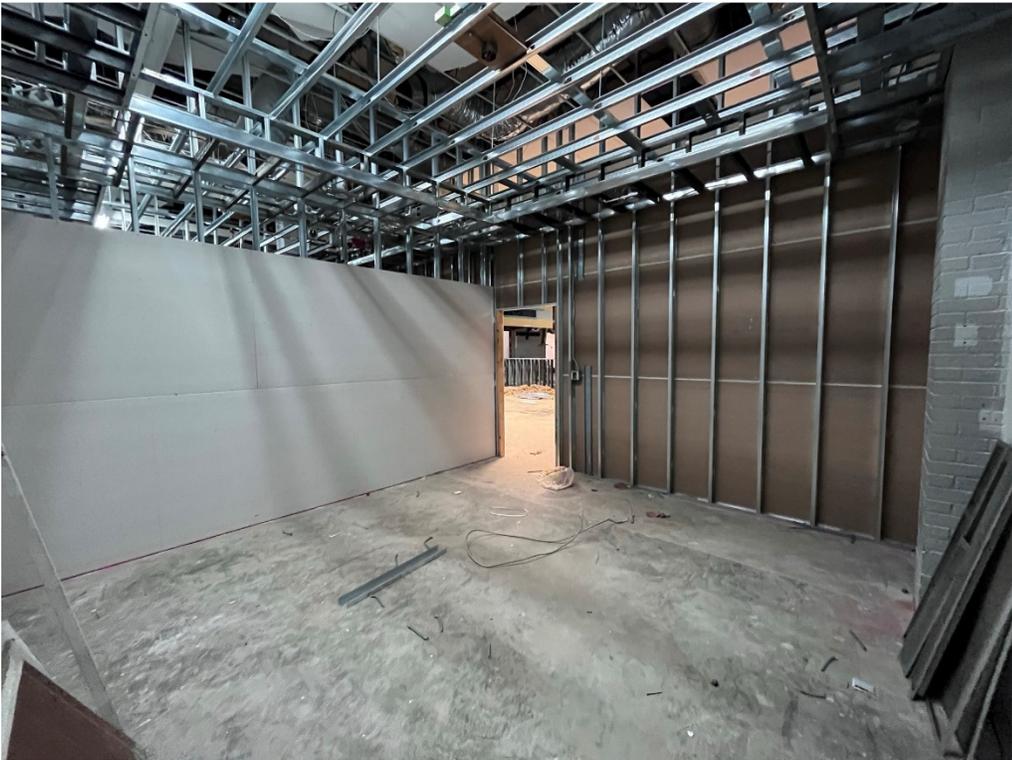
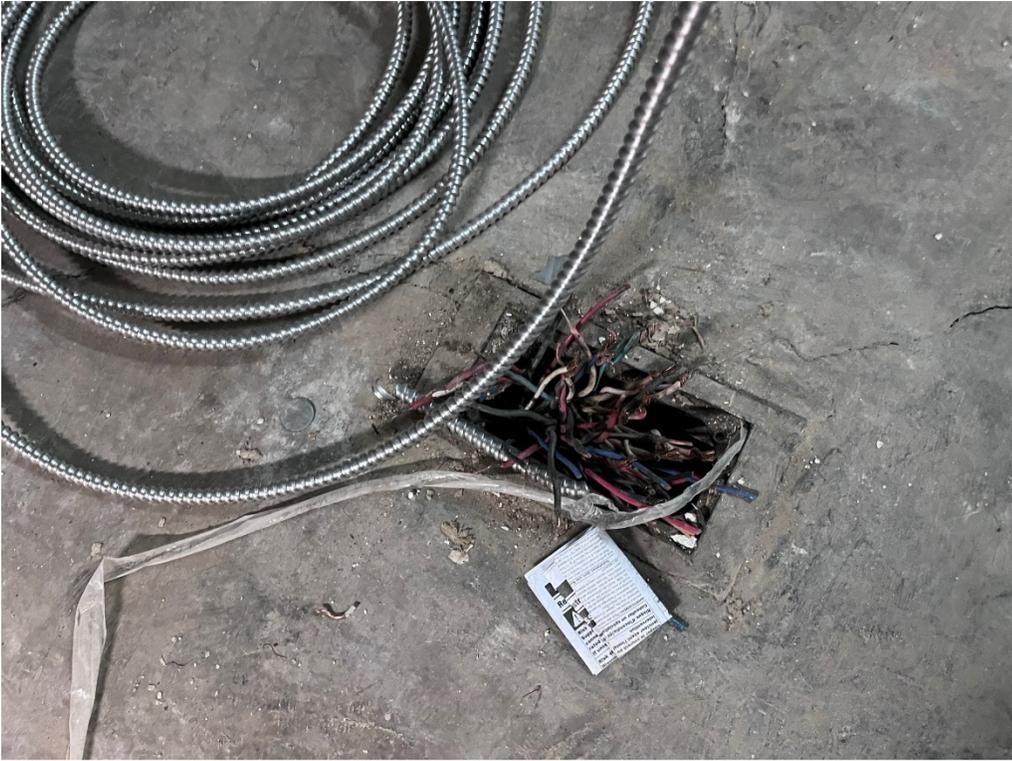
Figure 19 – West Warehouse Space; Drywall partially installed (electrical inspection by city?)

Figure 20 – West Warehouse Space; Drywall partially installed (electrical inspection by city?)

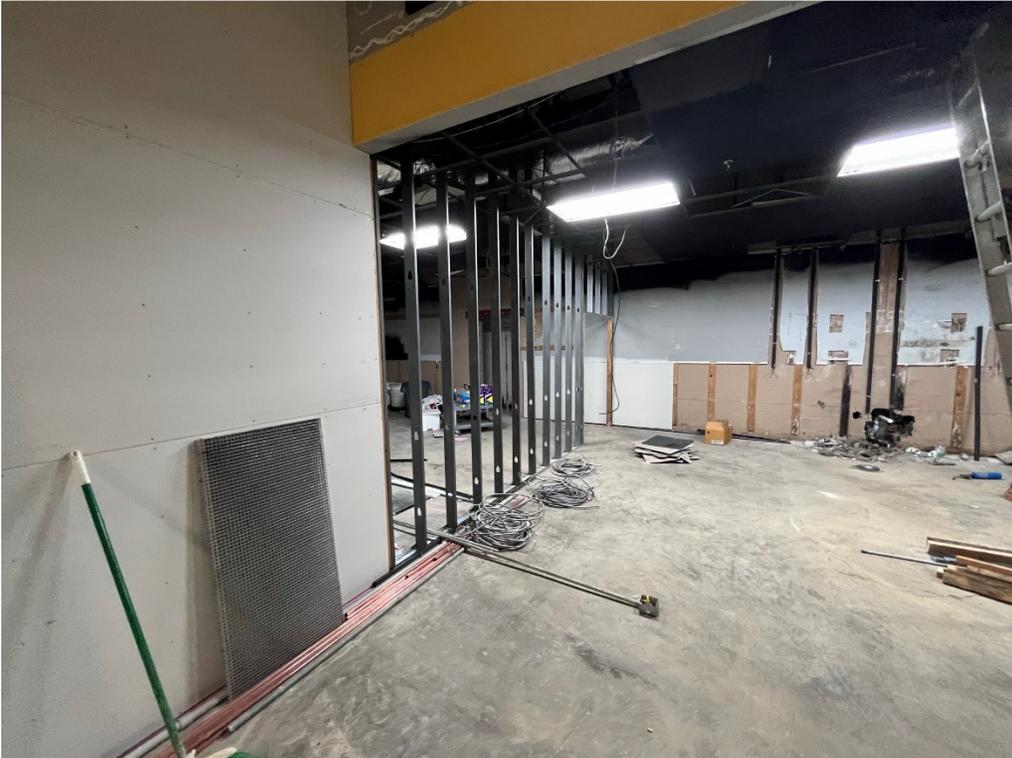
Figure 21 – NW Room Framed

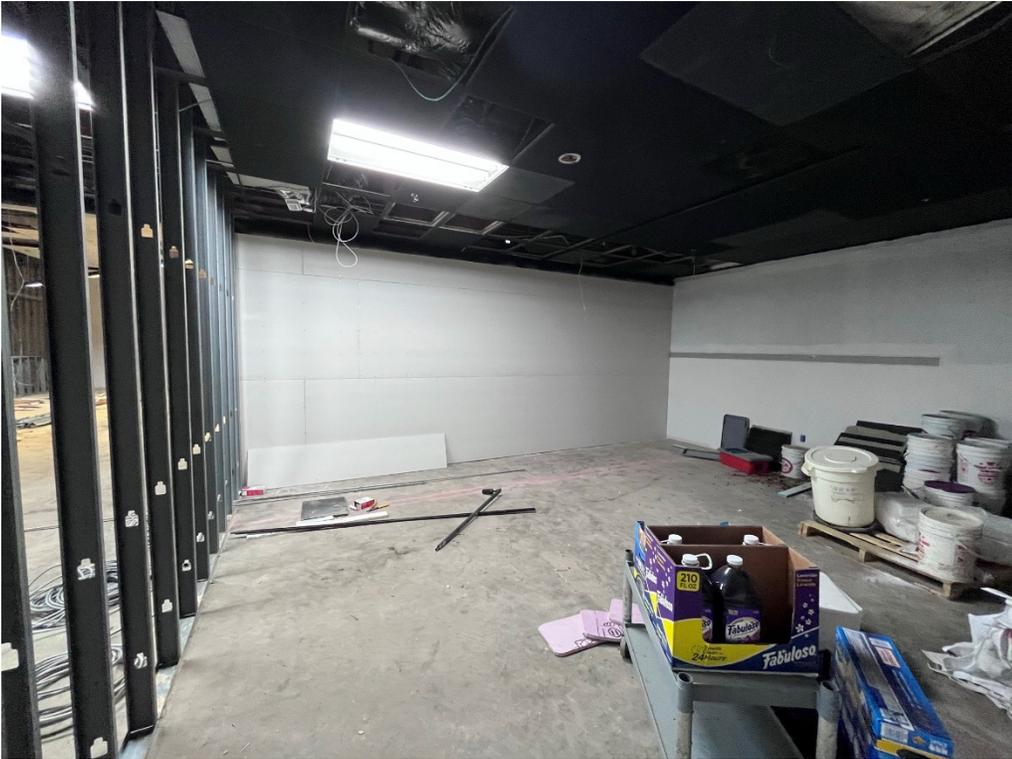
Figure 22 – NW Room framed and partially drywalled

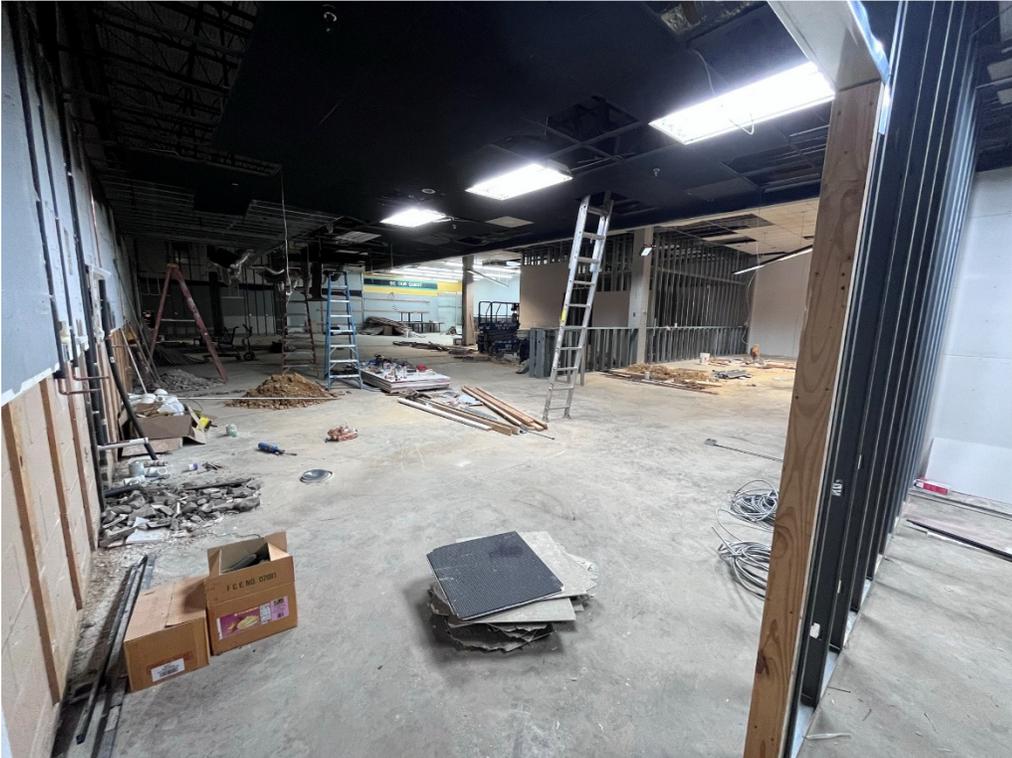
Figure 23 – View from NW looking SE

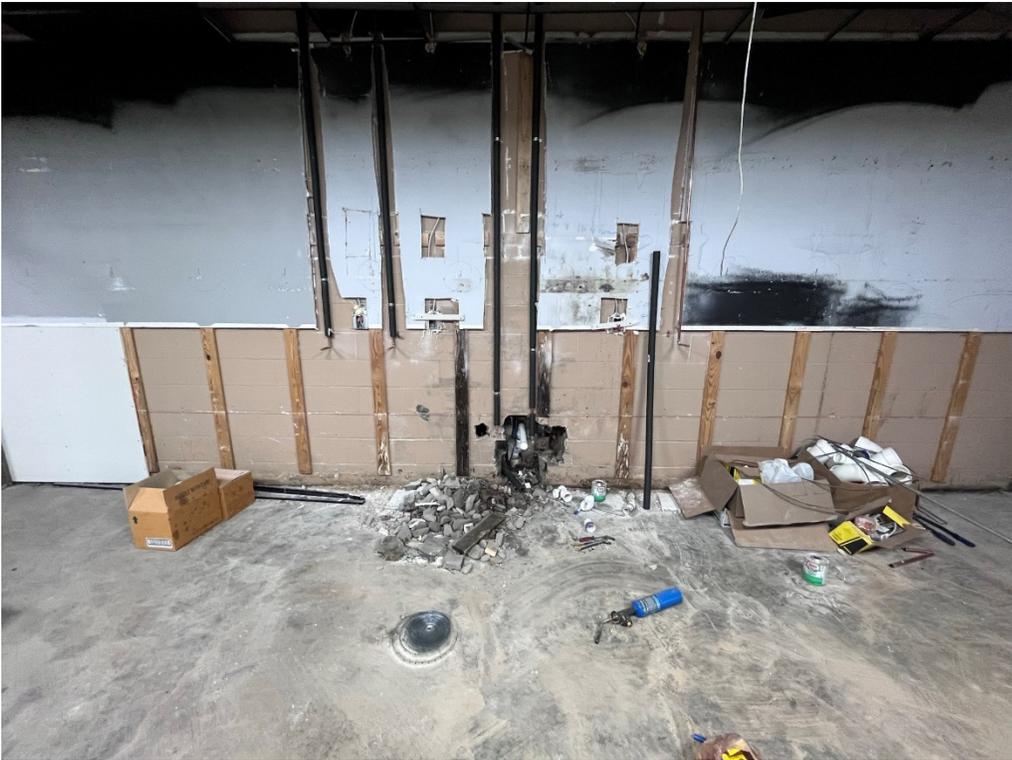
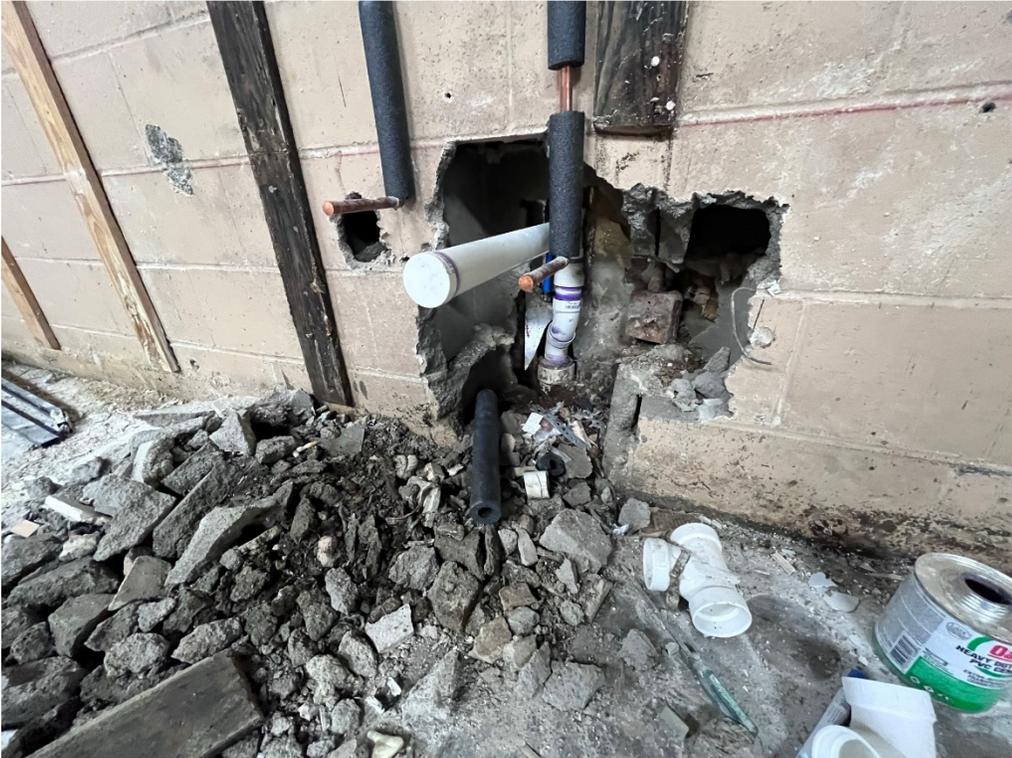
Figure 24 – Plumbing at North Central Wall

Figure 25 – Plumbing at North Central Wall

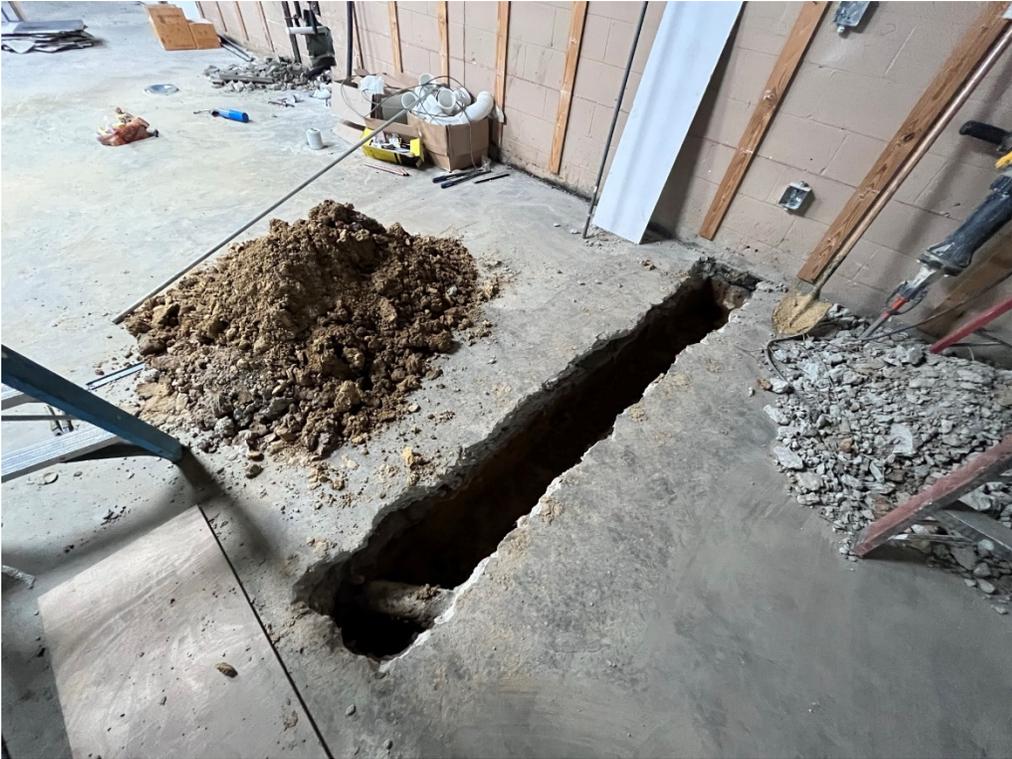
Figure 26 – Excavation at North Wall
