**Architect’s Field Report**

125 Hunt Circle, Madison, MS 39110

05 March 2022..... Date of Site Visit

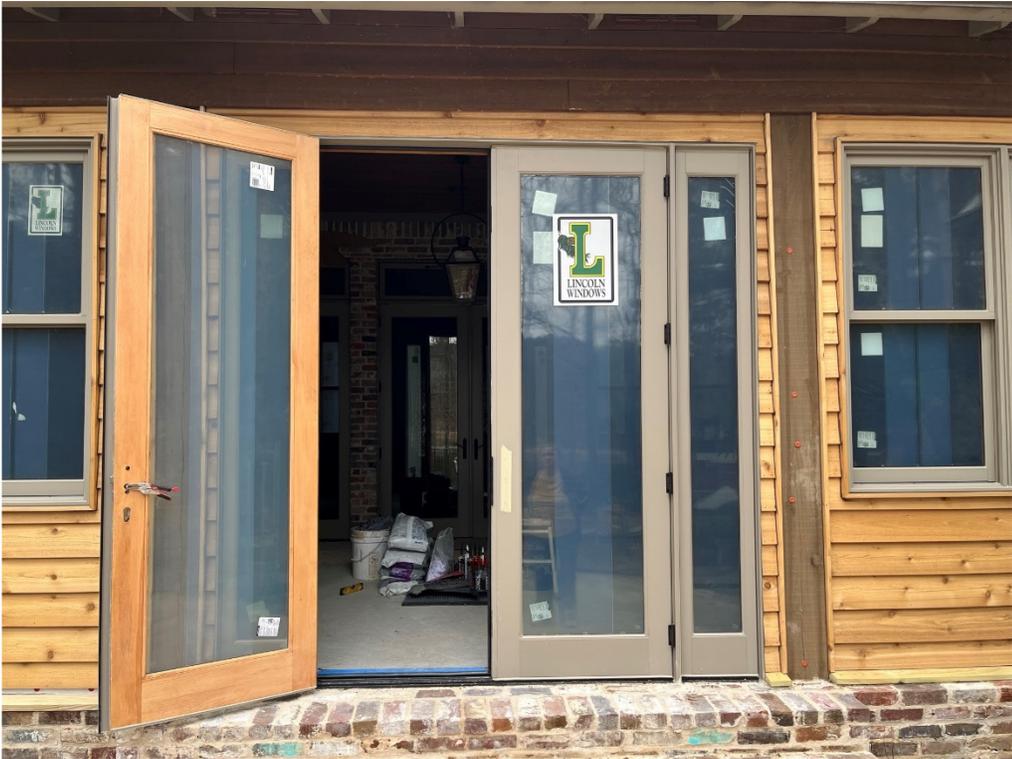
Figure 2 – Rear Project Work; noted siding above left is smaller than siding above door right

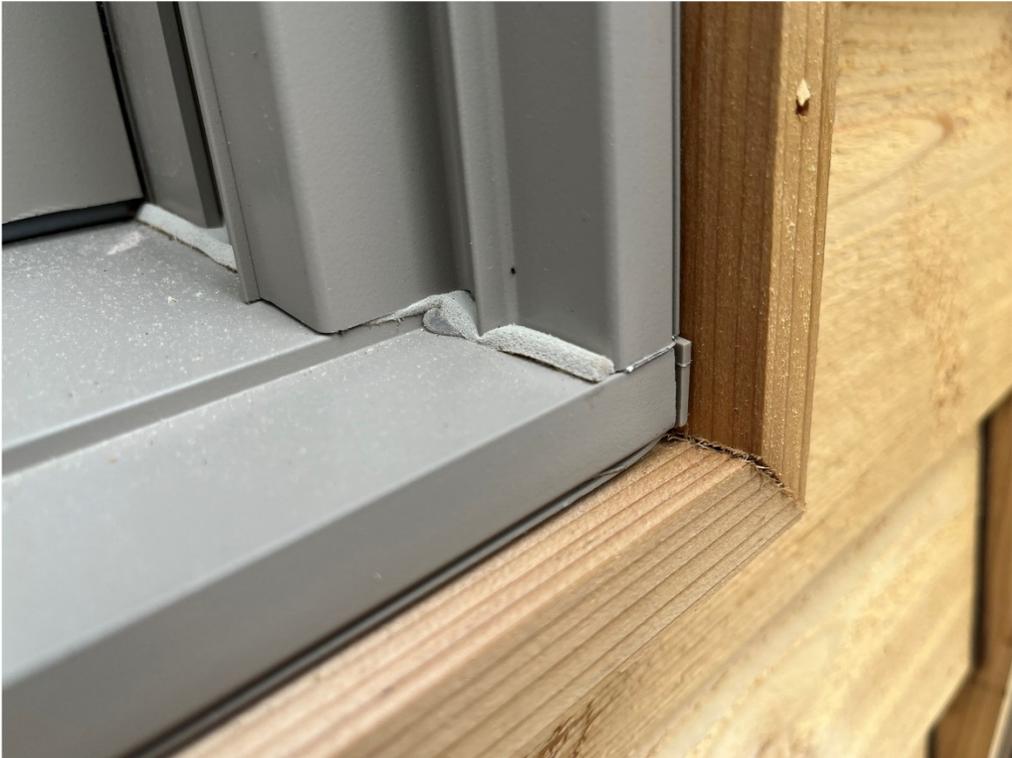
Figure 3 – Aluminum Clad Window Detail

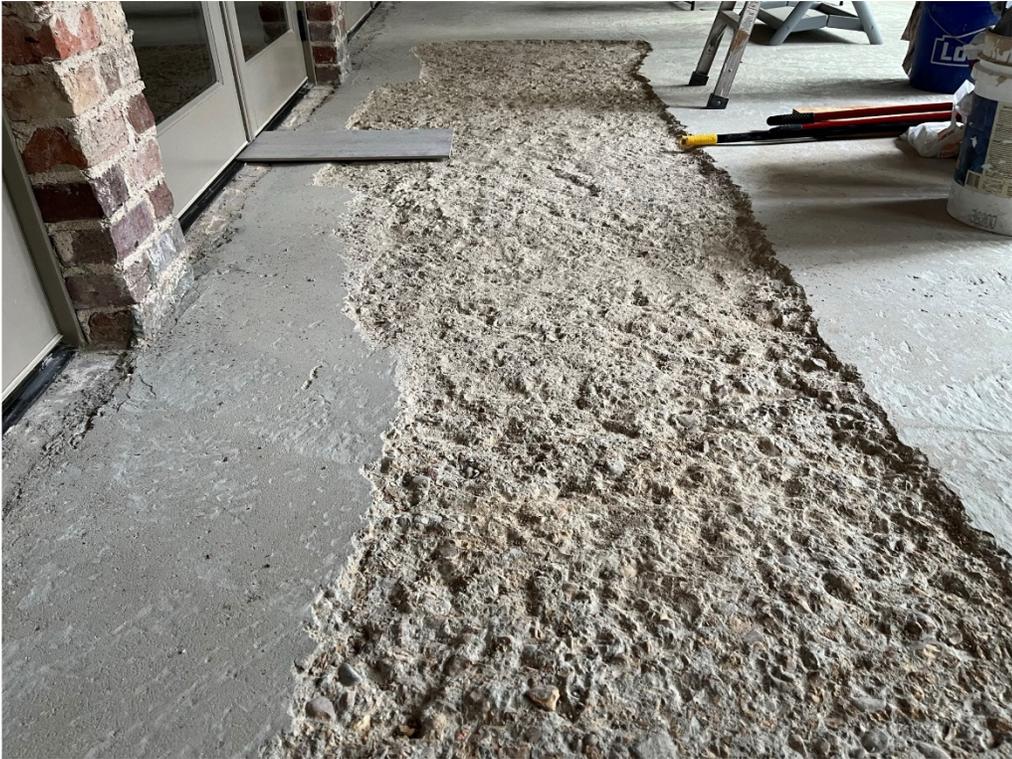
- The installed double door is out of level and requires reinstallation for level
- Installed concrete has been poured too high for the existing doors to open; the slab appears level for the most part but needs to come down at least ¾” everywhere in order for doors to open, tile to be installed, and the floor to be kept flat and level. In discussing with the Owner, there could be another remedy, but will need to be discussed further.
- Water is infiltrating the space. It appears to mostly be coming under the bottom plate of the new walls. I was able to note that flashing has not been properly installed at this location and is more than likely the cause of this issue. I advise that

Figure 4 – Remediation work, already begun, to lower slab

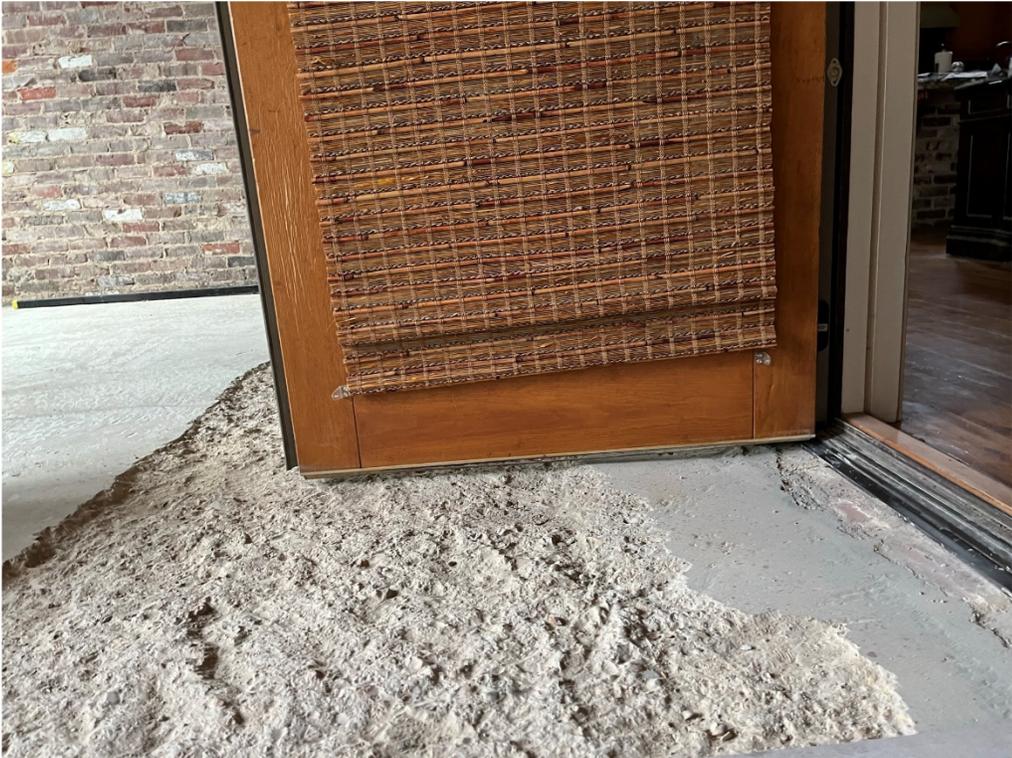
Figure 5 – Door will still not be able to open once tile is installed here

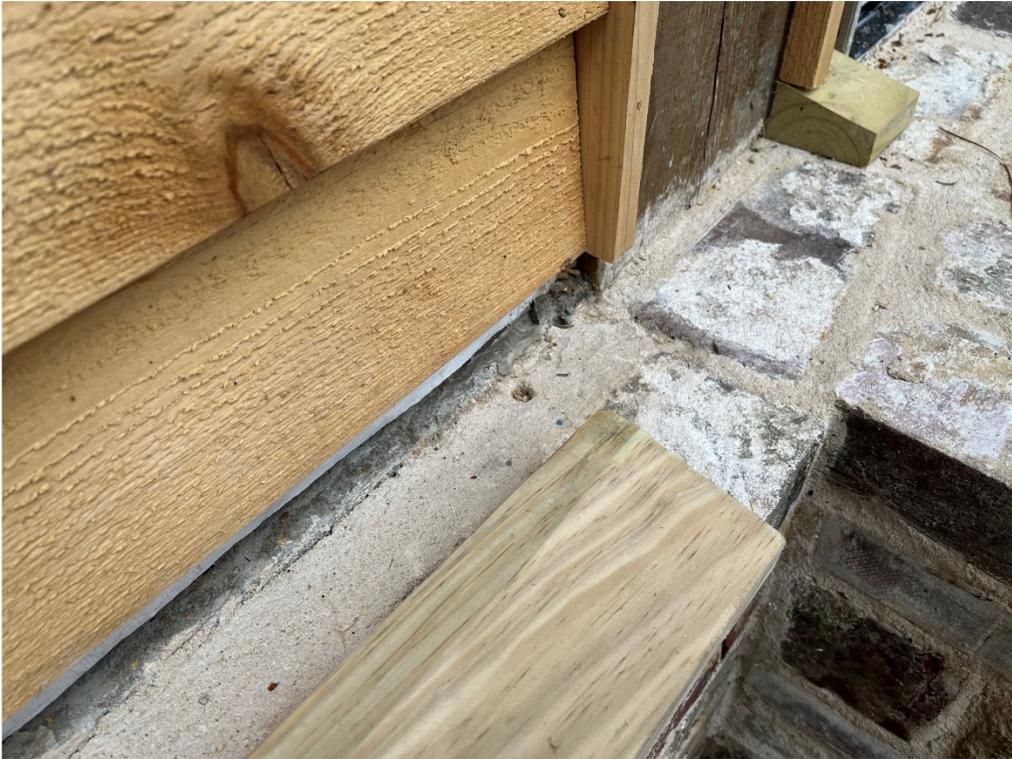
Figure 6 – Missing Flashing at this location

liquid flashing be applied at this point prior to install the bottom piece of trim. The material should be applied at least 2" up and 2" out and according to manufacturer's recommendations at the bottom corner of the wall and be applied to the sheet of OSB directly, allowing the vapor barrier to overlap. At the Columns, a face board should be applied after this and run from top to bottom as a full piece of wood. Attention should also be paid at the corner of the newly installed door unit so that sealant is fully applied.

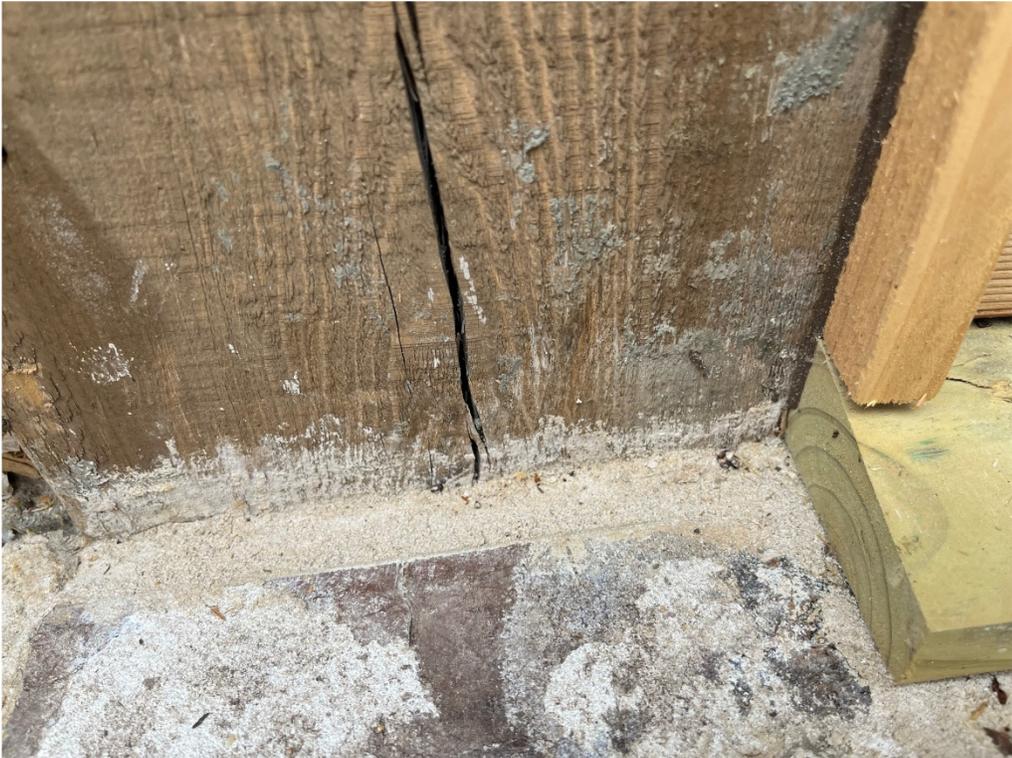
Figure 7 - Missing Flashing at this location

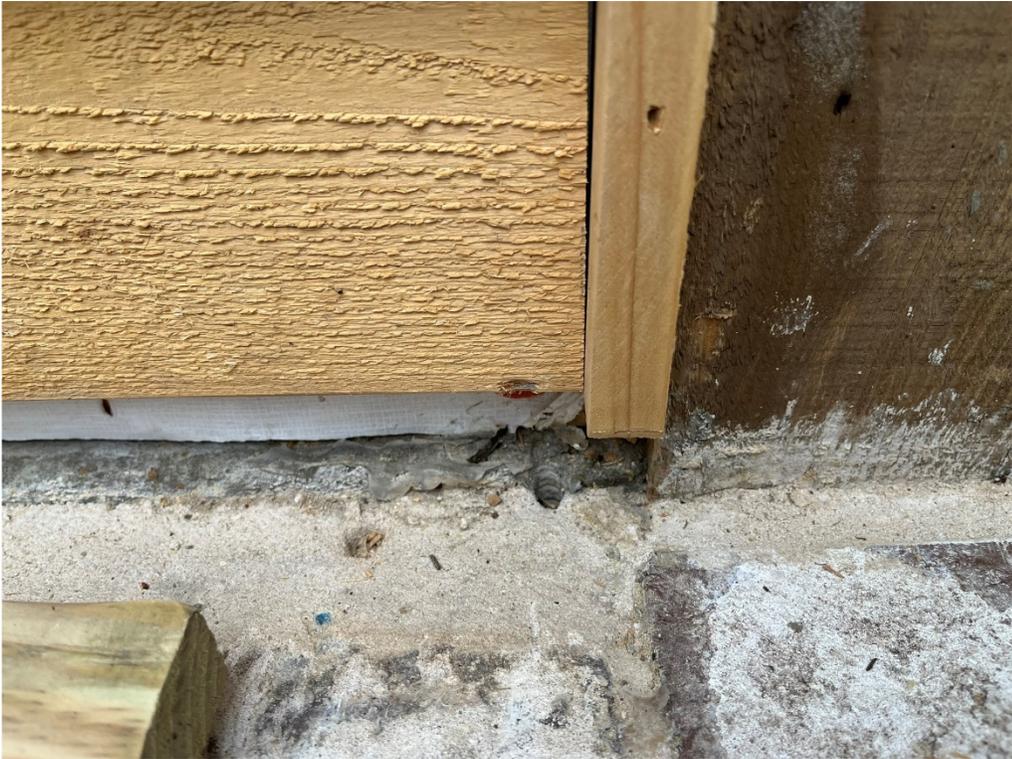
Figure 8 – Missing Flashing at this location

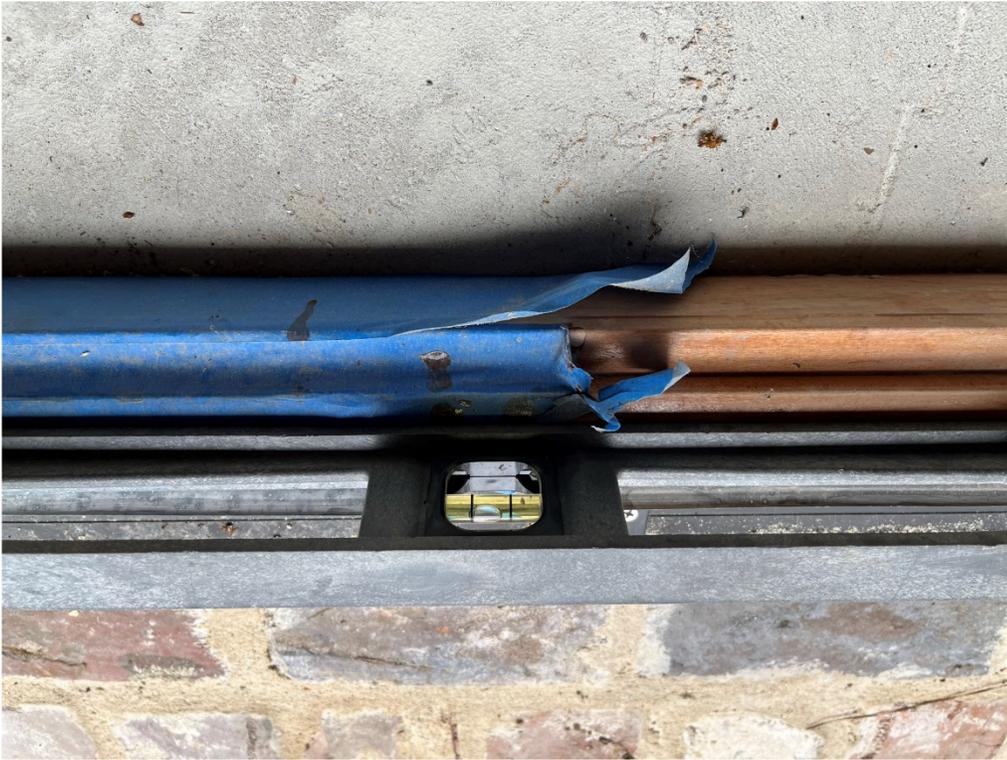
Figure 9 – Door Out of Level

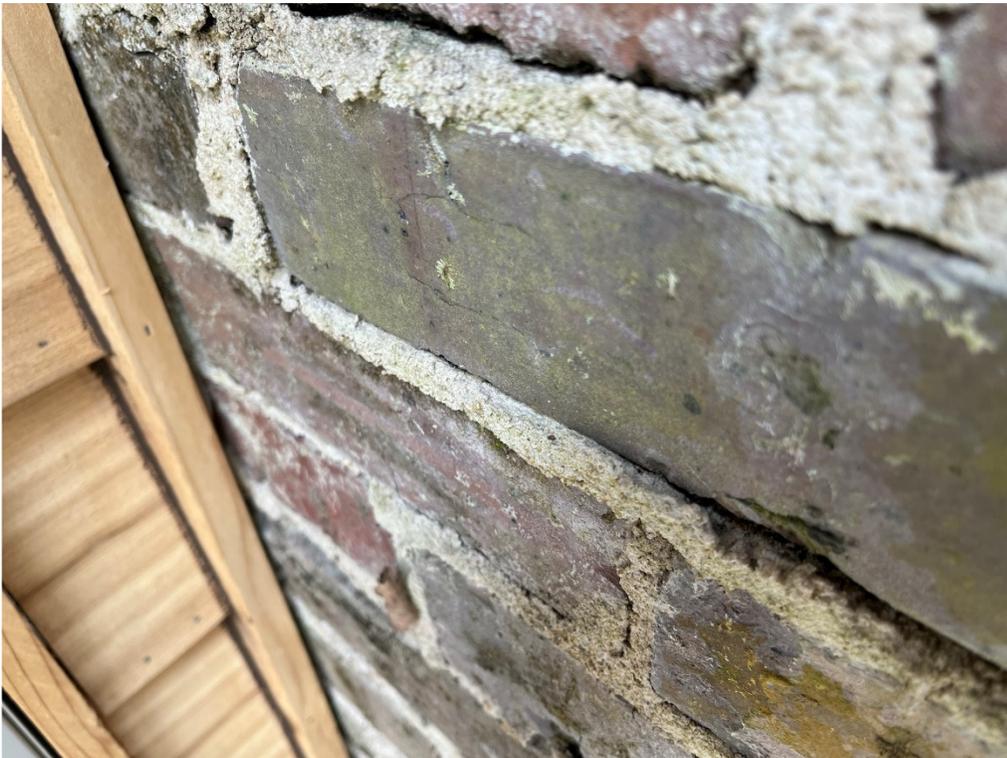
Figure 10 – Joint to be sealed

- Between the Existing Brick and new trim at the bedroom side of the project, sealant should be applied to keep water from infiltrating behind the vapor barrier.
